Natural Water Retention Measures

Case Study

Rehabilitation of heaths and mires on the Hautes-Fagnes Plateau

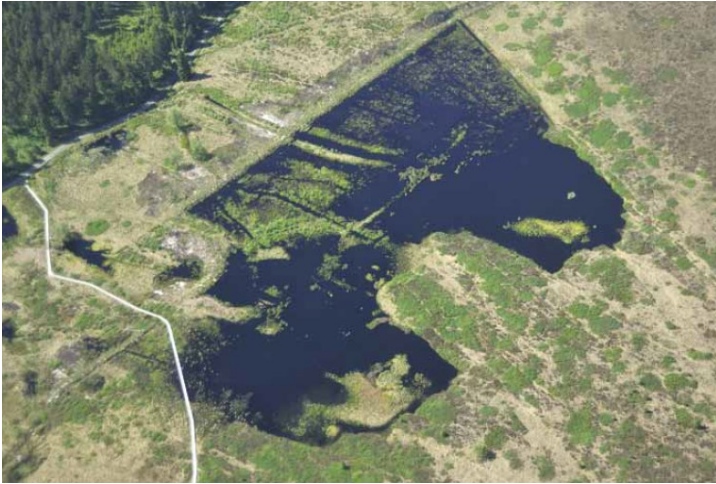
Figure 1 Importance of flooding the mires at the Mistens. On the left the Grenzweg. (Picture André Drèze, mai 2012)

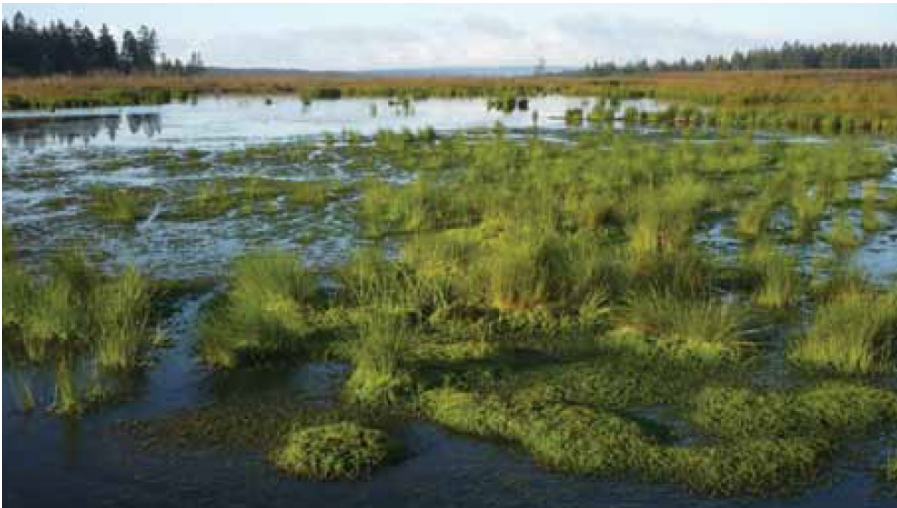
Figure 2 Sphagnum mosses "resurrection" in an area recently flooded (Parc naturel Hautes Fagnes-Eifel)

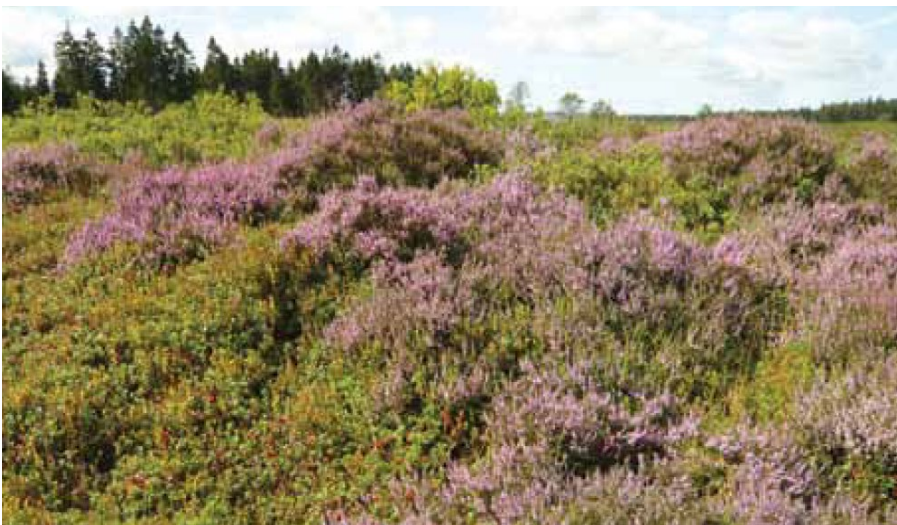
Figure 3 Heather and cranberries remarkable development in dry heaths (Parc naturel Hautes Fagnes-Eifel)
