# Natural Water Retention Measures

Service contract n°07.0330/2013/659147/SER/ENV.C1

## *Case Study* *Restoration of Oroklini Lake (Wetland)*

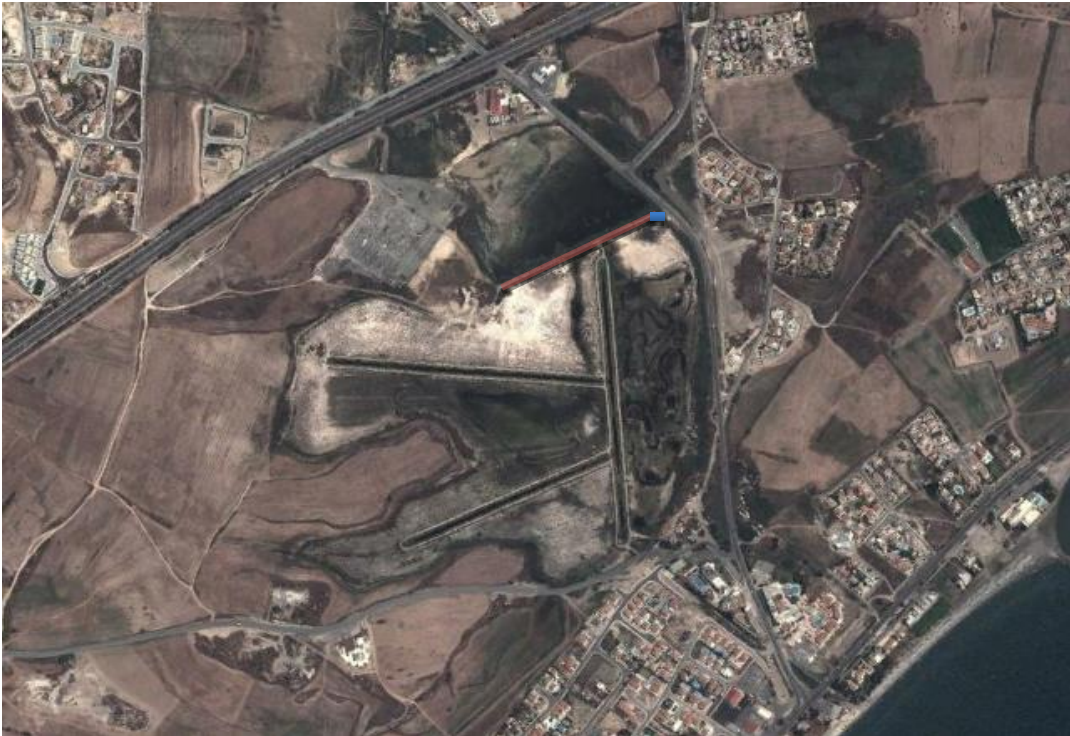
**Figure 1: A small earth-fill retention dam (shown with red) and an overflow sluice (shown with blue) were constructed in 1940, in order to retain water in the upper basin of the lake and prevent its desiccation. These were constructed in order to prevent water from spreading in the lower basin, create conditions favouring mosquitos. Photo: Google earth**

1.		
	2.		
	3.		
	4.		
5.			
Main factors and/or constraints that influenced the selection and design of the NWRM(s) in this application?	The presence of a sluice even if it had been previously breached and was not functional, was a determining factor for the restoration works. It was preferred and deemed appropriate to restore the present structure instead of designing and constructing a new weir. The restoration of vegetation was limited to species already present in the lake due to the brackish character of the lake.

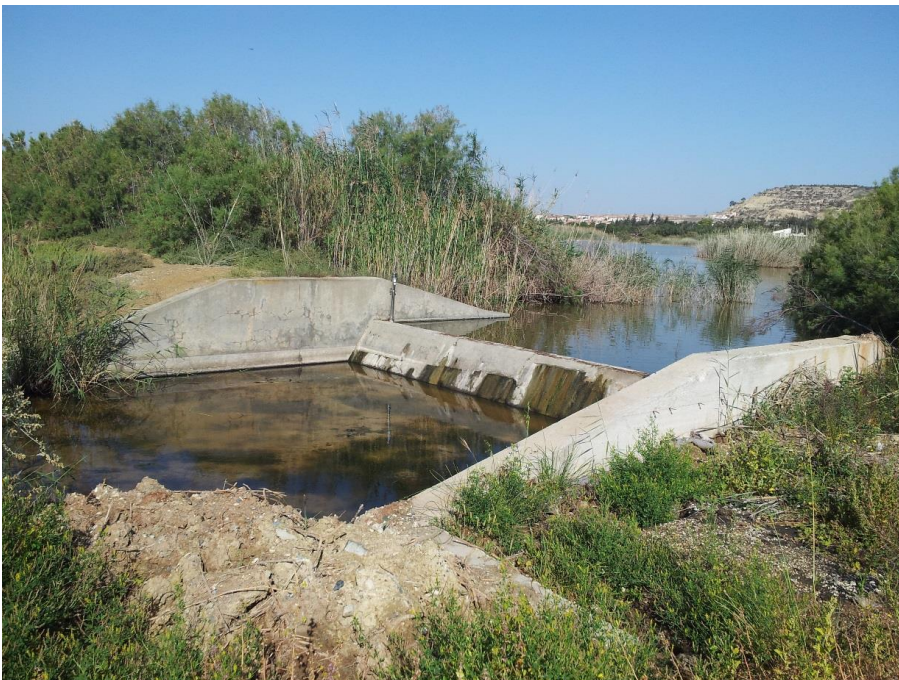
**Figure 2 : The sluice was abandoned and partly destroyed, and therefore water was released in the lower parts of the wetland. In 2012, the sluice was repaired in the framework of a Life+ project and the retention capacity of the upper basin was increased. Photo: IACO Ltd (2013)**

Design capacity	The calculations indicate that a maximum of 23 428m <sup>3</sup> of water can be retain according the design of the restored weir. Besides this, other benefits such as the biodiversity enhancement and the water pollutants removal cannot be calculated.		
Reference to existing engineering standards, guidelines and manuals that have been used during the design phase		<i>Reference</i>	<i>URL</i>

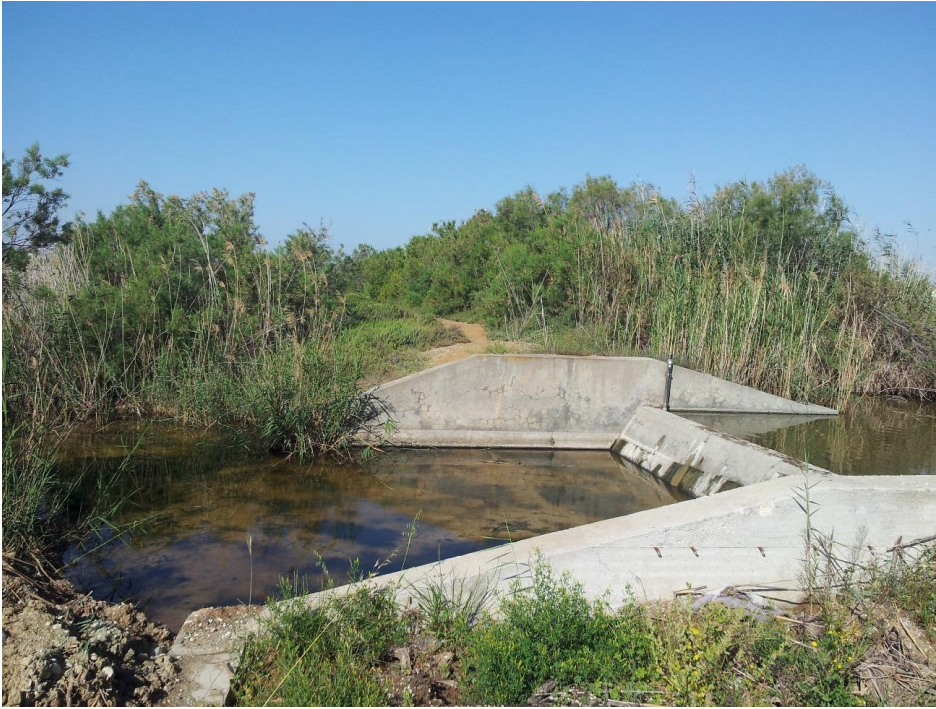
**Figure 3 : The earth embankment is about 292m long and has been covered with dense vegetation.  
Photo:IACO Ltd (2013).**

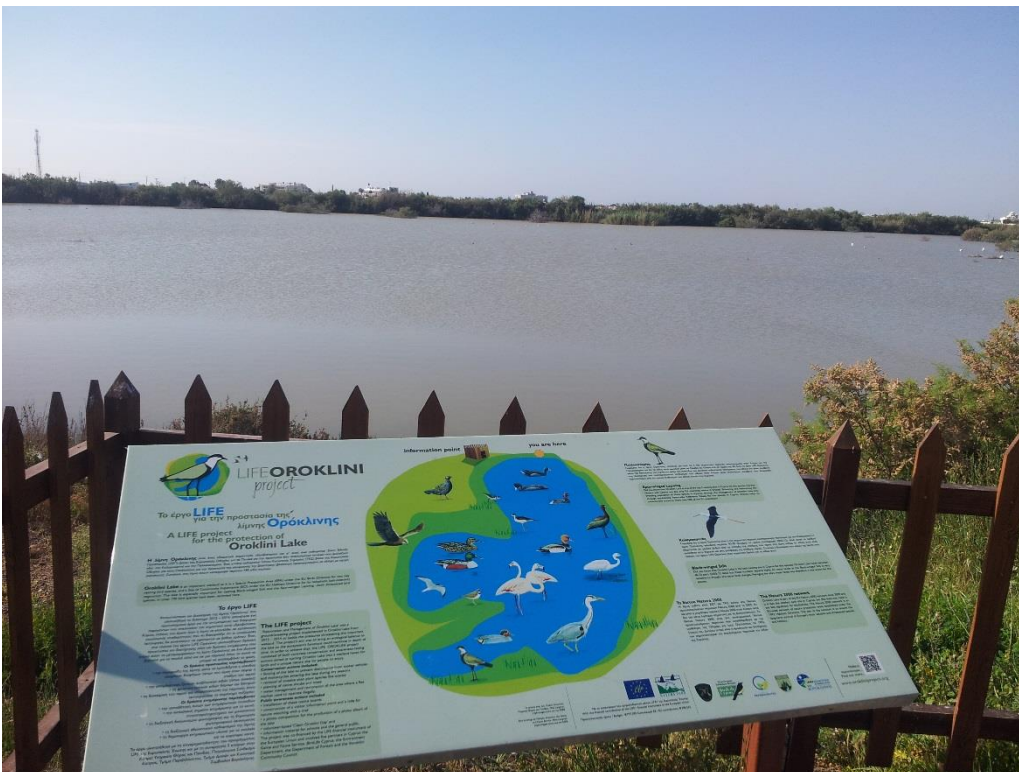
**Figure 4: As a result of the NWRMs, the upper basin of the lake retains sufficient amounts of water for sustaining aquatic habitats and species, even in dry years. Photo: IACO Ltd (2013).**

Impact category (short name)  Select from the drop-down menu below: ↓	Impact description (Text, approx. 200 words)	Impact quantification (specifying units)	
		Parameter value; units	% change in parameter value as compared to the state prior to the implementation of the NWRM(s)
Runoff attenuation / control	<i>Describe the impact on runoff reduction and/or control</i>		
Peak flow rate reduction	<i>The measures have minor impact in flow reduction due to the high capacity of the lake.</i>		
Impact on groundwater	<i>It is expected that the ground water level will be slightly increased due to the low permeability of the lake sediments.</i>	<i>Infiltration rate: &gt;3mm/h</i>	NA
Impact on soil moisture and soil storage capacity	<i>Describe the impact on the soil moisture and soil retention capacity</i>		
Restoring hydraulic connection	<i>The measures will decrease the outflow of water towards the sea and therefore improve the hydro morphological characteristics of the lake.</i>	Although a temporal lake, water was present in the lake until September; i.e. 1-2 month more than previous years.
