Environment

#### I. Basic Information

# CS: Stream ČernýPotok, CZ

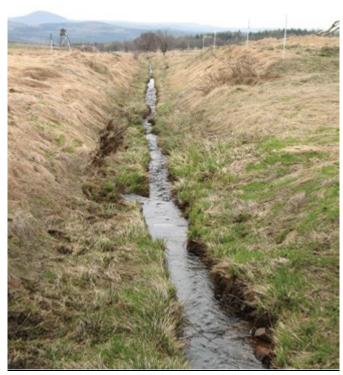
Figure 1: Section of Cerni porok stream before restoration (© J. Rous in Jongepierová et al. (2012), p. 74) Source : Jongepierová I., Pešout P., Jongepier J. W. & Prach K. (eds) (2012): Ecological restoration in the Czech Republic. – Nature Conservation Agency of the Czech Republic, Prague, 147 pp. <u>http://chapter.ser.org/europe/files/2012/12/Ecological-Restoration-in-the-Czech-Republic1.pdf</u>

3. Local Chapter Teplice – Fergunna	-	Responsible for monitoring and maintainance	
The application was initiated and financed by	Initiated by the Nature Conservation Agency of the Czech Republic Financed by the Free State of Saxony, Operational Programme Environment			
What were specific principles that were followed in the design of this application?	at were followed in the design variety in current and calm riges			
	Modifications within the channelized streambed were not sufficient to respect all these criteria, therefore new streambeds were proposed and constructed. They were reconnected with the remains

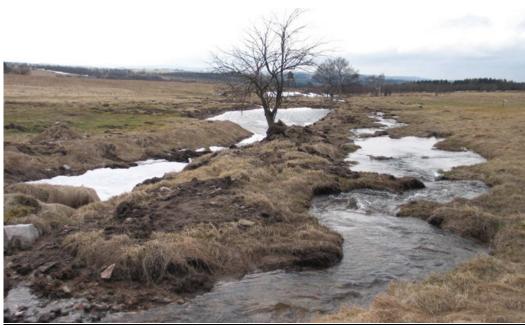
Figure 2: Section of Cerni Potok stream after restoration (© J. Rous in Jongepierová et al. (2012), p. 75) Source : Jongepierová I., Pešout P., Jongepier J. W. & Prach K. (eds) (2012): Ecological restoration in the Czech Republic. – Nature Conservation Agency of the Czech Republic, Prague, 147 pp. http://chapter.ser.org/europe/files/2012/12/Ecological-Restoration-in-the-Czech-Republic1.pdf

of the original stream course or directed freely to the alluvial meadows. The volume of the new beds was designed at 30-day design flows (or max. one-year flows).			
Area (ha)	Number of hectares     Number of ha       treated by the NWRM(s).     7.4			
Area (ha)	Both new and restored marshes with still or running waters 43,000 m2			
Design capacity	<ul> <li>Restored stream sections (including adjustment of channelized streambeds and making water flow into the alluvium), 4,030 m</li> <li>Natural overflow in case of Q100 floods (along meandering segment in the alluvium) 74,000 m<sup>2</sup></li> <li>Pools with marshes (restored or created marsh habitats), 9,630 m<sup>2</sup></li> </ul>			
Reference to existing engineering standards, guidelines and manuals that have been used during the design phase	Reference     URL       1.     National standards and protocols			
Main factors and/or constraints that influenced the selection and design of the NWRM(s) in this application?	The described restoration project, dealing with stream restoration including a large flooded alluvium, represents the first of its kind in the Czech Republic in extent and approach. New methods were applied in the design of shape and course of the streambed, and their successful implementation was enabled by good collaboration between investor, designer and subcontractors. Changes in the natural stream courses, degradation of stream habitats as well as considerable changes in natural hydrology were the main motivations for working out a restoration project. Restoration works originally started as partial re-establishment of small shallow pools and adjustments of the channels, but finally led to a comprehensive project aimed at restoring the natural hydrology in the entire Nature Reserve. The area of interest is an important site for many rare and endangered plants (e.g. Menyanthes trifoliata, Pinguicula vulgaris) and animals (e.g. shore-birds, amphibians) of wetlands. It was necessary to take the conservation of these species into account during the restoration works.
