Natural Water Retention Measures

Case Study

Restoration of Wetlands in the Western Lowland Area of the Dümmer Lake

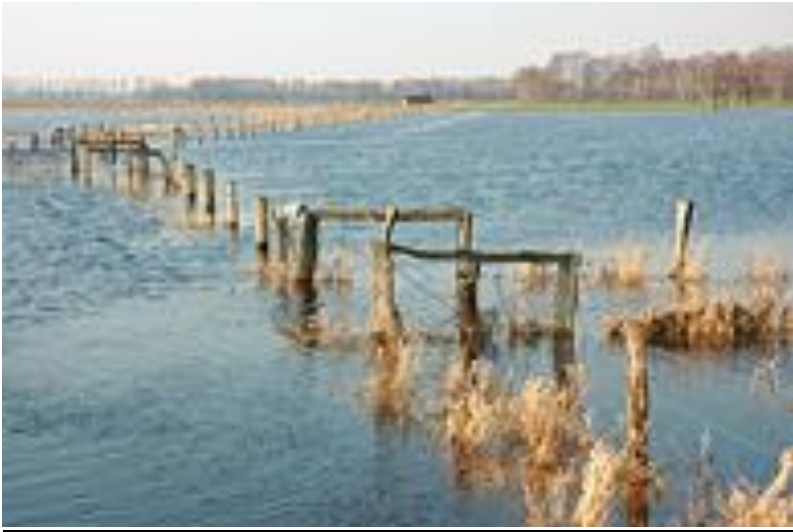
Figure 1 Winter waterlogging on grassland (Source: NLWKN)

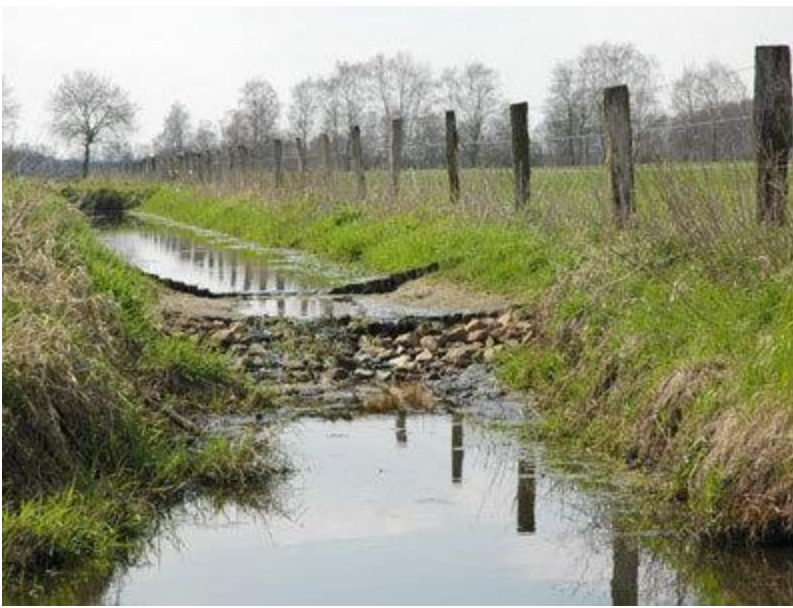
Figure 2 Overflow congestion in the project area (right from the ditch a newly constructed fence line) (Source: NLWKN)
