Natural Water Retention Measures

Case Study

Water retention management in the broader area of Ancient Olympia, Elia, Greece

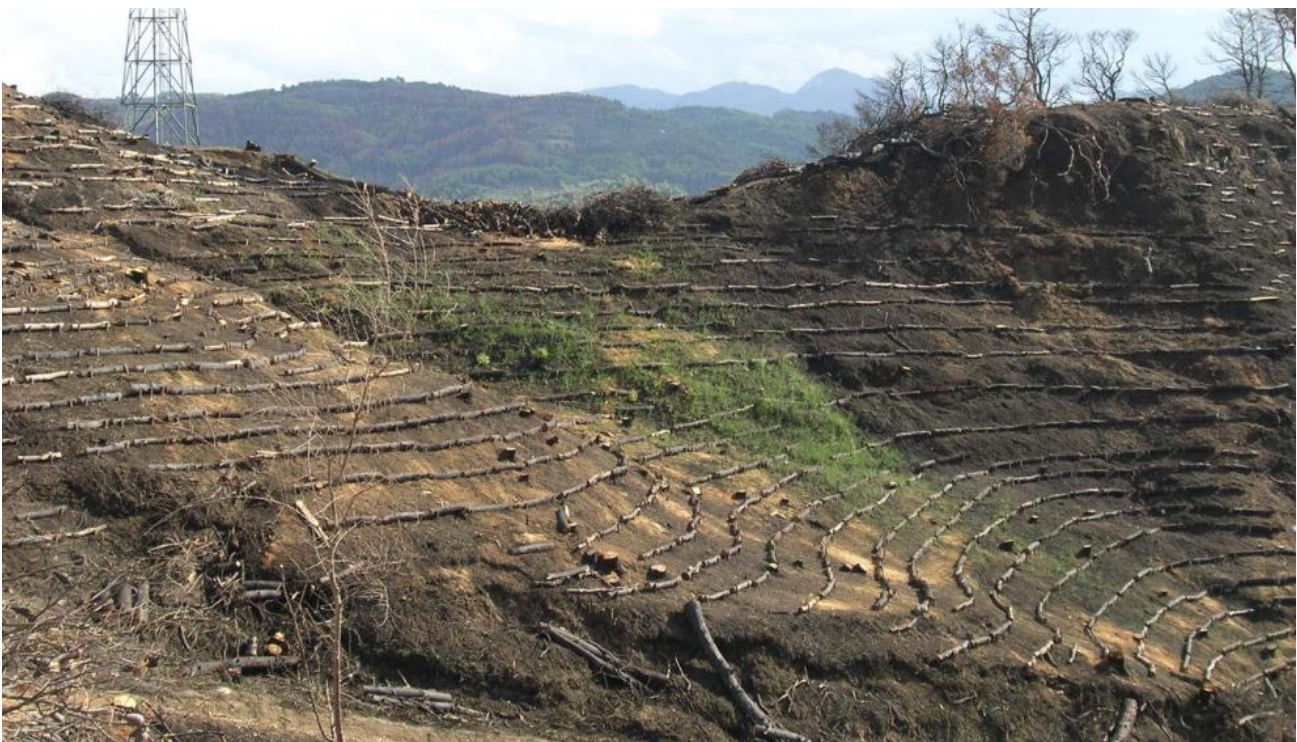
Picture 1: Kronios Hill after the implementation of the measures, Continuous Lines (Bourletsikas Athanasios, 2014)

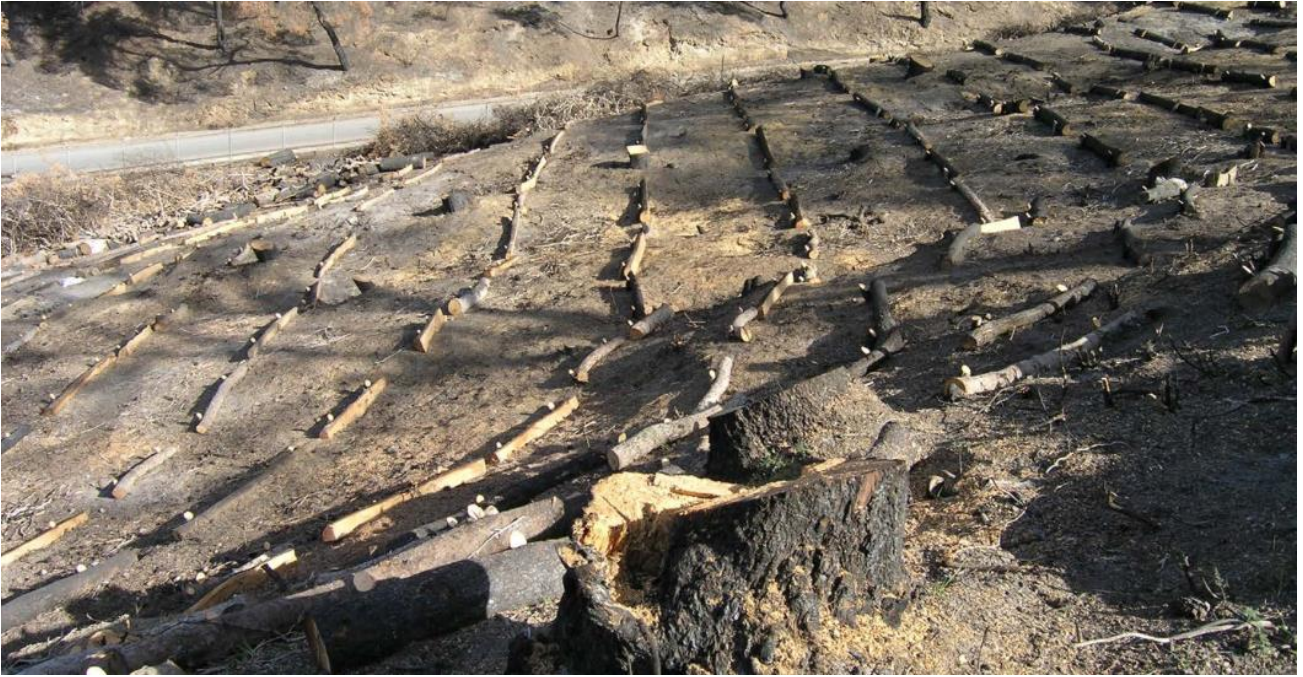
Picture 2: Olympic Academy Hill after the implementation of the measures, Empty Space Lines, (Bourletsikas Athanasios, 2014)

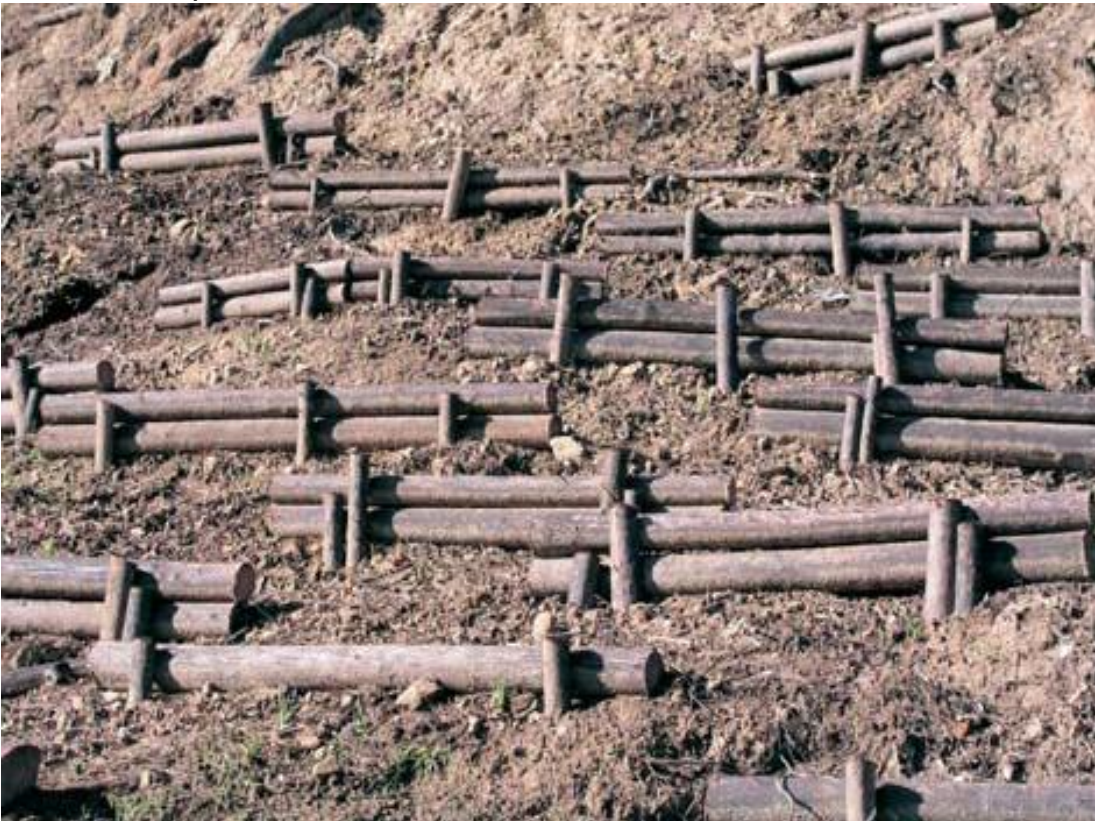
Picture 3: Detail of the timber structures (26-11-2007) (Lyrintzis Georgios, 2011)

Impact description (Text, approx. 200 words)	Impact quantification (specifying units)	
		Parameter value; units	% change in parameter value as compared to the state prior to the implementation of the NWRM(s)
Runoff attenuation / control	<i>The installation of temporary structures utilizing locally available timber have been designed to reduce the hill slopes thus control the surface runoff. This measures reduces the velocity of water volume leading to decreasing the intensity and frequency of floods. Also the timber structures retain water for longer period enabling the infiltration/percolation and recharge of aquifers.</i>		
Peak flow rate reduction	<i>The peak flow rate is reduced due to the obstacle of the timber structures. This measures reduces the velocity of water volume resulting in the decrease of floods intensity.</i>
