I. <u>Basic Information</u>

Application ID	Spain_02				
Application Name	Órbigo River ecological status improvement (Stretch I): Duero River Basin				
Application Location	Country: Spain		Country 2:	No	
	NUTS2 Code			ES41-Castilla y León	
	River Basin Distr			ES020-DUERO	
	WFD Water Bod	ly Code		Water body: 02R1103 INFRAECO (2011a)]	7_08 [Source:
	Description		This application has been to 23.5 km long stretch (so Orbigo River (Duero Rive in the northwest of Spain.	tretch I) of the	
Application Site Coordinates	Latitude: *NOTE: Action was implemented in a segment (A= initial point; B= terminal point) • A (42,65652004N [ETRS89 (UTM 30M)] • B (42,49623126N [ETRS89 (UTM		Longitude: *NOTE: Action was in a segment (A= initiaterminal point): • A (-5,82186704 [E' 30M)] • B (-5,88084182 [E' 30M)]	al point; B= IRS89 (UTM	
Target Sector(s)	30M)] Primary:	Hydromo	rpology	[301 v1)]	
	Secondary:	Forest	1 0/		
Implemented	Measure #1:	N3 (Flood	dplain reconn	ection)

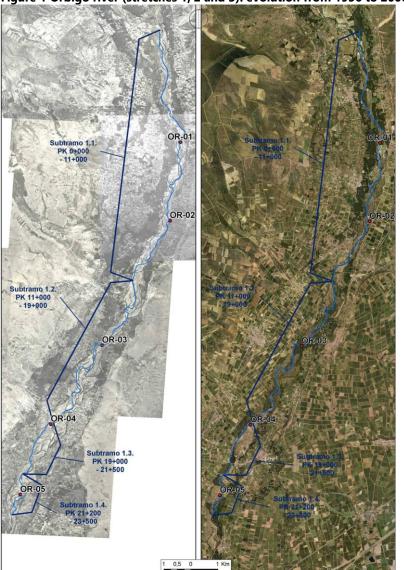
Figure 2 Órbigo river stretch (detail): channelization, and land use and morphological changes (1956-2006)

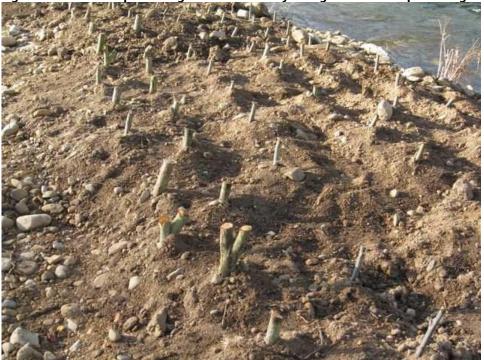
Figure 5 Recovery of flood prone areas: natural attenuation of floods
